Badger Army Ammunition Plant Deconstruction Feasibility Study

Brad Guy, Penn State University
Tim Williams, University of Florida
Bill Bowman, Austin Habitat for Humanity

on behalf of
USDA Forest Products Laboratory
Madison, WI
March 2004

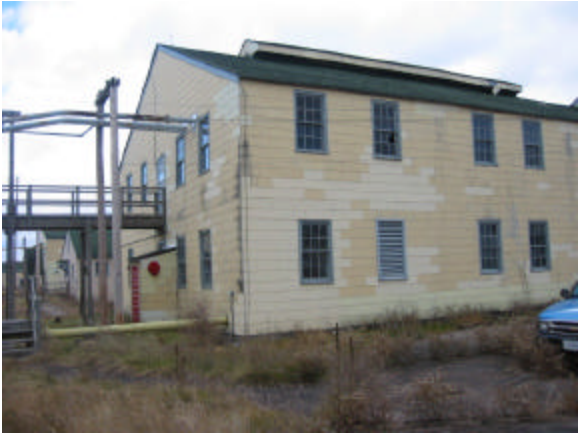
3022 Beater House

This building had water damage, high degree of entanglement of MEP systems and all wood surfaces were painted, assumed to be lead-based paint.

Building 3022 was qualitatively rated a three (3) for deconstruction potential, and therefore not considered for further analysis.

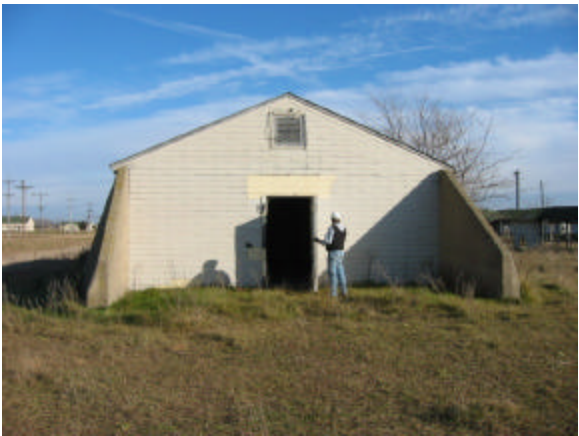
6586-5 Inert Storage

Building 6586-5 had 3 of 4 exterior walls that were poured concrete, the roof structure was salvageable, and sheathing on the one wood-framed wall was asbestos-containing materials.

Building 6586-5 was qualitatively rated a three (3) for deconstruction potential, and therefore not considered for further analysis.

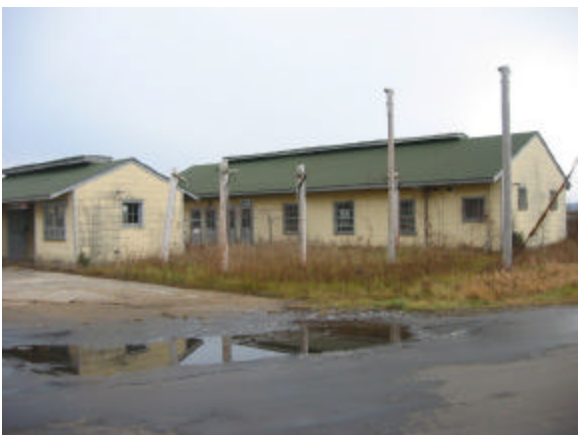
6543-5 Gatehouse

Building 6543-5 was a simple one-story building with high proportion of interior finishes to salvageable lumber. Good building for volunteer or low-skill laborers.

This building was qualitatively rated a four (4) for deconstruction potential and was not considered for further analysis.

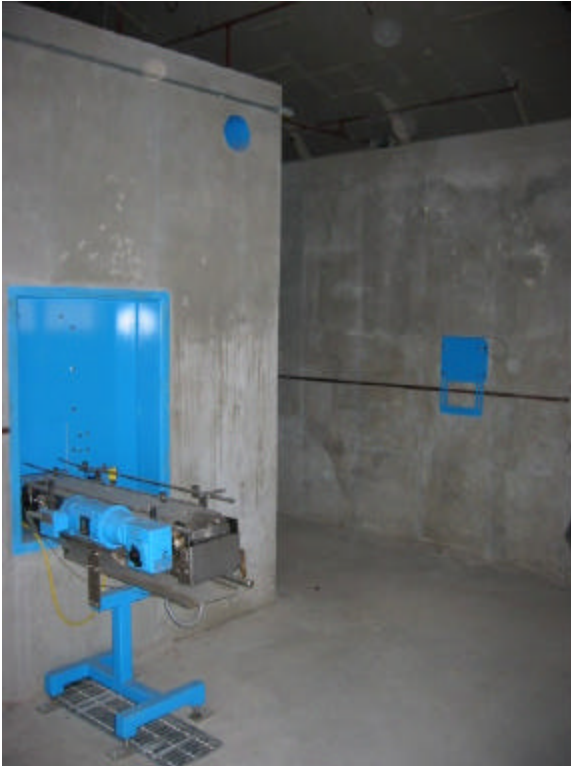
6864-1 Cementing House

This building had light wood frame exterior walls and interior walls entirely cast-in-place concrete. It had minimal salvage and was qualitatively rated a two (2) and therefore not considered for further analysis.

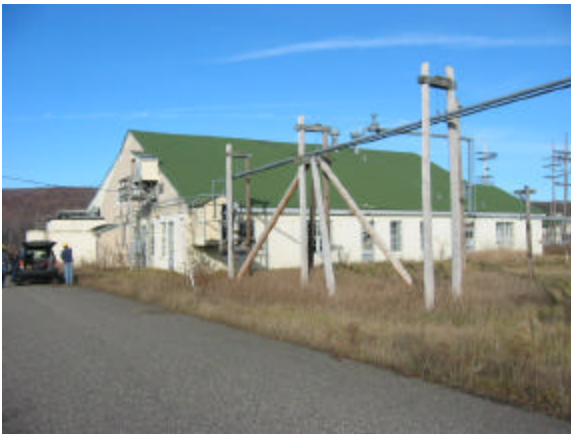
Type 1 - 224 Ballistic House and Range

Building 224 had large sized lumber unpainted lumber trusses in the roof with concrete or CMU first-story exterior walls and a large amount of non-salvageable interior finishes.

This building was qualitatively rated a four (4) for deconstruction potential, and although a low score, it was considered for further analysis for a roof-only deconstruction.

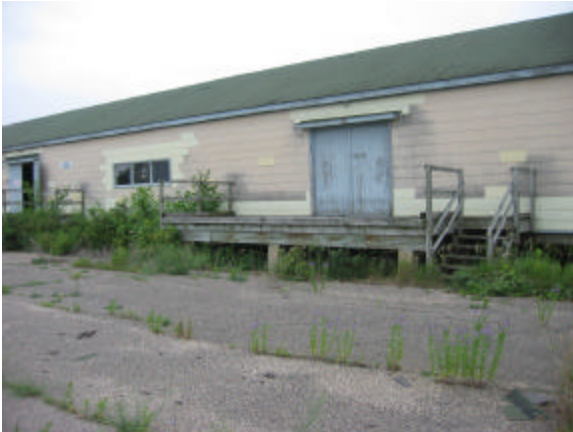
Type 2 - Building 275

Building 275 was a large one-story warehouse with raised wood floor structure and minimal interior partitions and finishes.

This building was qualitatively rated an eight (8) for deconstruction potential and was considered for further analysis.

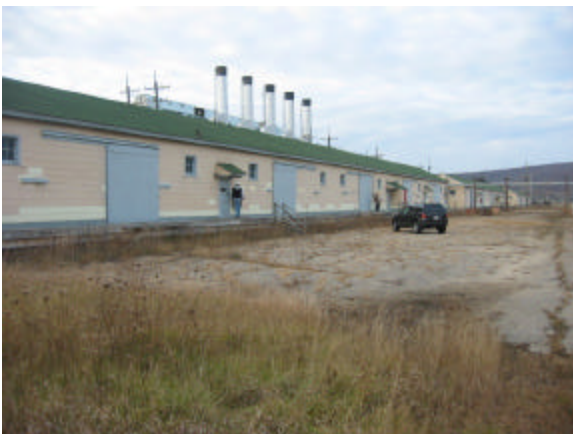
Type 2 similar 507-4 - Warehouse

This building has a raised wood floor structure with minimal interior partitions and finishes.

Building 507-4 was qualitatively rated a eight (8) for deconstruction potential, and was considered for further analysis.

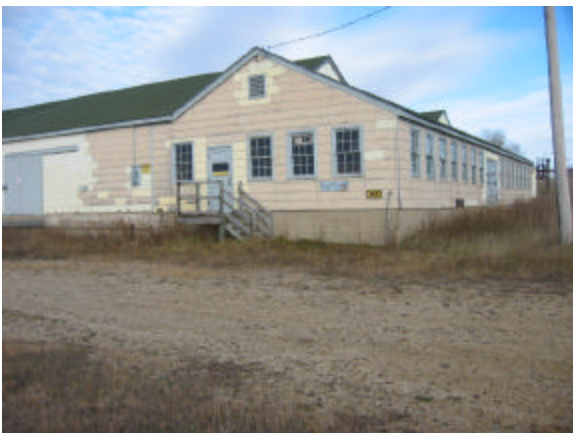
Type 2 alternate - 6401 Bulk Storage

This building is identical to 275 Warehouse, with the exception that the floor here is a raised slab.

Building 6401 was qualitatively rated a seven (7) for deconstruction potential, and was considered for further analysis.

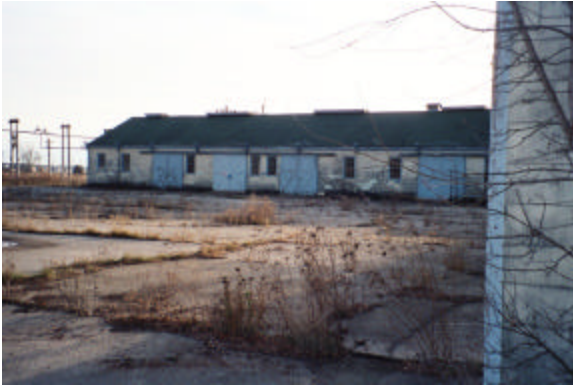
Type 3 - 305 Gun Storage and Repair

Building 305 had a light wood frame exterior, exposed roof structure, 2x sheathing and minimal interior finishes. There were significant numbers of openings in the exterior walls and a concrete slab.

Building 305 was qualitatively rated a seven (7) for deconstruction potential, and was considered for further analysis.

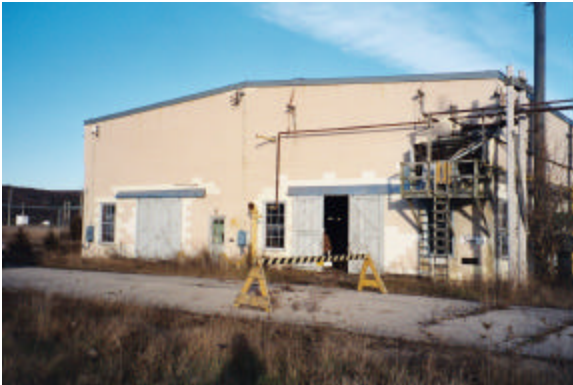
Type 4 - 700 Compressor House

Building 700 had an exposed roof structure and walls and large dimensional lumber with minimal interior finish. All wood appeared to be lead-based paint, salvage % dependent on reuse options or stripping of LBP. It had a concrete slab and concrete pits.

Building 700 was qualitatively rated a three (3) for deconstruction potential based upon the presence of LBP, but otherwise would be highly ranked, and for this reason was considered for further analysis.

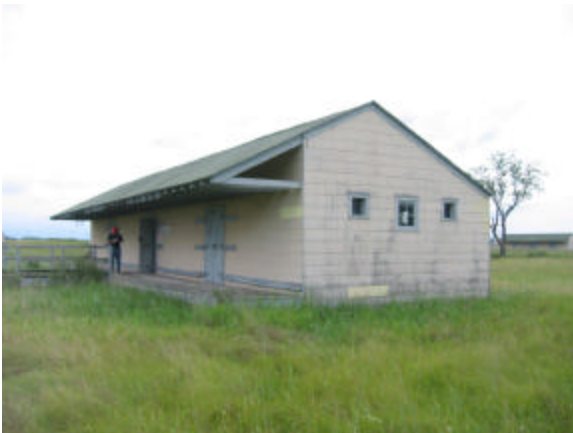
Type 5 - 1750 Rest House

Building 1750 is small one-story with raised wood floor and interior wood finishes.

This building was qualitatively rated an eight (8) for deconstruction potential and was considered for further analysis.

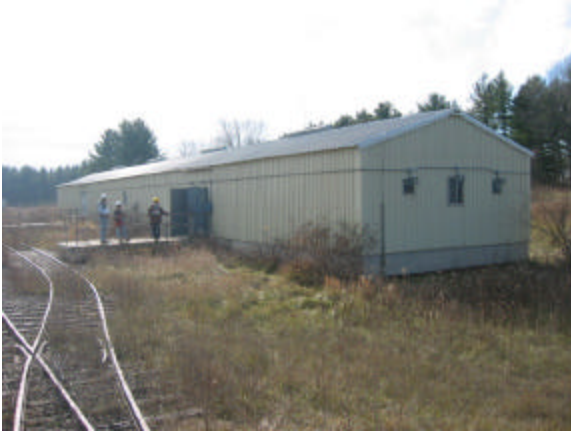
Type 5 alternate - 1750-26 Rest House

Building 1750-26 is a metal frame and cladding on concrete slab. Slab contains mastic may be asbestos containing material. Metal frame and exterior skin are either entirely recyclable or able to be dismantled and reassembled elsewhere

This building was qualitatively rated an eight (8) for deconstruction potential but was not considered for further analysis due to lack of data for dismantling metal buildings.

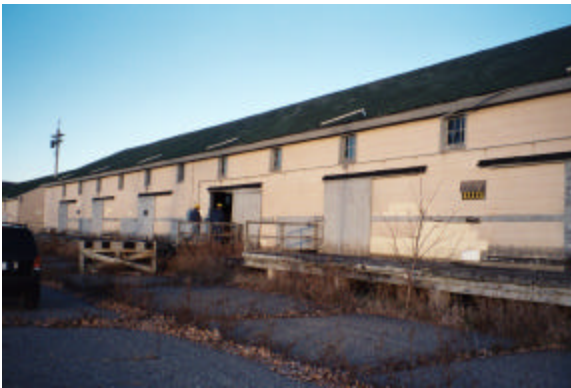
Type 6 - 1885-2 Box Storehouse

Building 1885-2 has exposed roof and walls and large dimensional lumber columns and reuses with minimal interior finishes and concrete slab and stem walls.

This building was qualitatively rated a seven (7) for deconstruction potential and was considered for further analysis.

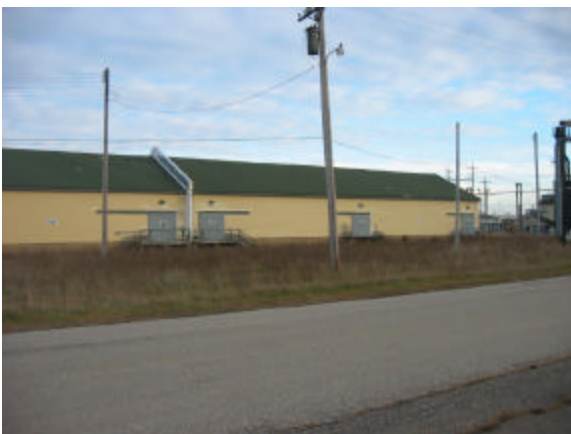
Type 6 similar - 3000 Pulp & Cotton Warehouse

Building 3000 had large dimensional lumber in roof trusses no interior partitions or debris on a raised concrete slab.

This building was qualitatively rated an eight (8) for deconstruction potential and was considered for further analysis.

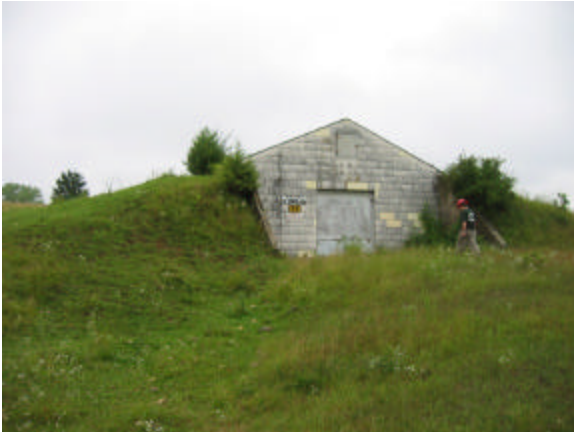
Type 7 - 1906 Magazine, Standard – Berm

Building 1906 w/ berm has unpainted novelty siding on interior ceiling and a roof rafter structure and wood-framed front wall with concrete slab.

This building was qualitatively rated a nine (9) for deconstruction potential and was considered for further analysis.

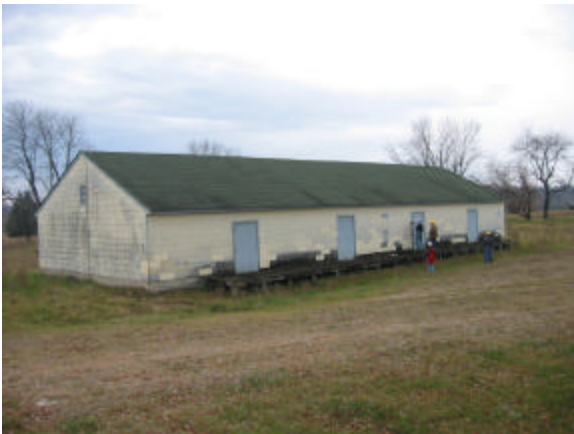
Type 7 similar - 1932-32 Magazine, Cannon

Building 1932-32 interior is entirely unpainted, salvageable lumber with concrete slab. Excellent building for volunteer or low-skill laborers.

This building was qualitatively rated a nine (9) for deconstruction potential and was considered for further analysis.

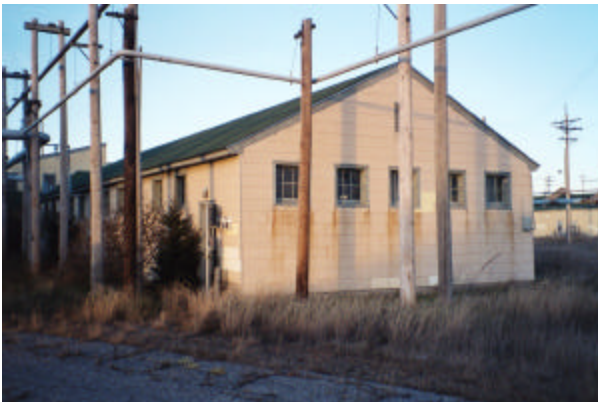
Type 8 - 3036 Change House

Building 30306 is framed in small dimensional lumber with ceiling and interior wall drywall and concrete slab.

This building was qualitatively rated an four (4) for deconstruction potential and was considered for further analysis due to its small scale and potential for unskilled labor.

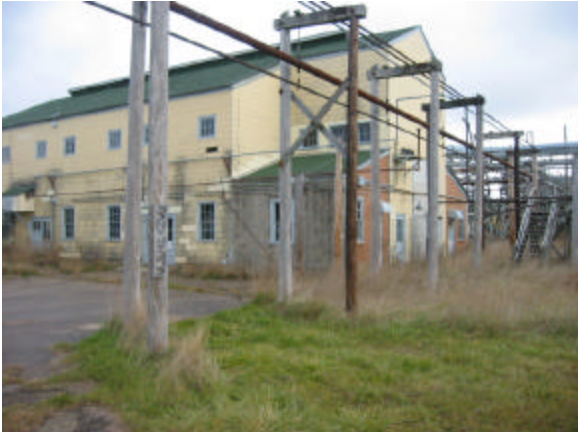
Type 9 - 3555 ACR Building

Building 3555 had unpainted large timbers in the roof structure and post and beam walls with considerable entanglement of various pipes.

This building was qualitatively rated a seven (7) for deconstruction potential and was considered for further analysis.

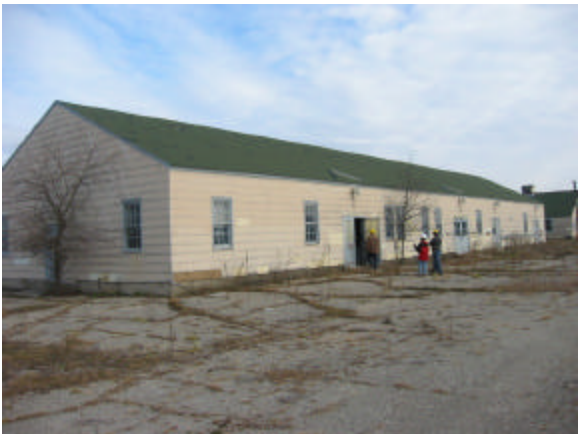
Type 10 - 6822 Maintenance Shop

Building 6822 had an exposed roof structure with plywood sheathing with concrete slab. Exterior sheathing is granule asphalt material over suspect friable asbestos fiber board.

This building was qualitatively rated a six (6) for deconstruction potential and was considered for further analysis.
