# Case Study Report #1, 6153 Portal Way Ferndale WA, circa 1940 Barn

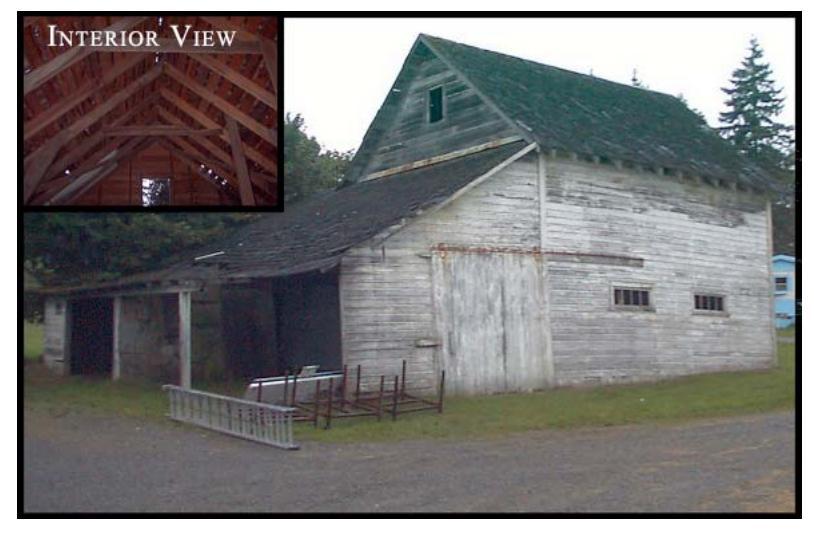
The project was built nearly entirely of wood, utilizing balloon-frame construction. The bulk of the salvageable material was found in the main area (the central 480 square feet) of the two-story barn. The two attached shed roofs to the north and the west were considered valueless from a salvage perspective. Even in the best parts of the structure, there was some unsalvageable material due to rot or pest damage.

**Roof**: The roof of the structure was composed of 382.6 linear feet of 2" x 6" rafters, 16" on center, 814.83 linear feet of 1"x 6" sheathing, 8" on center, and 611.12 square feet of cedar shingles. The total surface area of the roof was1,427.12 square feet. The roof showed a great deal of wear, light being visible in many areas, and was estimated to be only 10% salvageable.

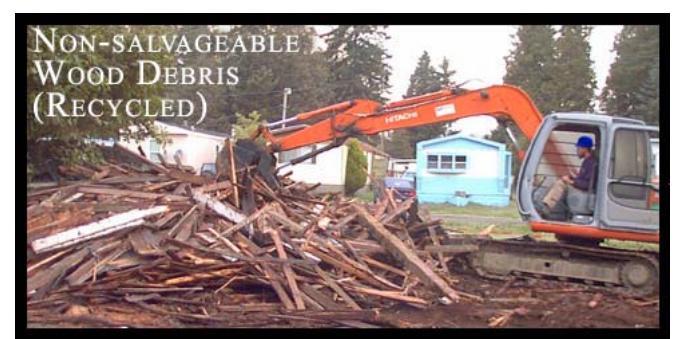
When the bottommost section of flooring was exposed, the remaining tongue and groove flooring was pried from the sub floor, inspected for quality and sorted accordingly. The remaining sub-floor was left for the track-hoe, as it had no salvage value. The rest of this "hybrid" approach to demolition/ deconstruction is similar to conventional, machine-based demolition practices. One person operates the machine, while the remaining laborers work on the ground to rake what small debris the machine cannot pick up. After the sub-floor and poured concrete foundation were removed, the

deconstruction crew was ready for final sight cleanup— the exposed earth within and around the building's footprint was raked clean.
